**IDRAIM – stream hydromorphological evaluation,  
analysis and monitoring system**

## **Illustrated Guide to the Answers**

**Guidebook for the evaluation of stream morphological  
conditions by the Morphological Quality Index (IQM)**

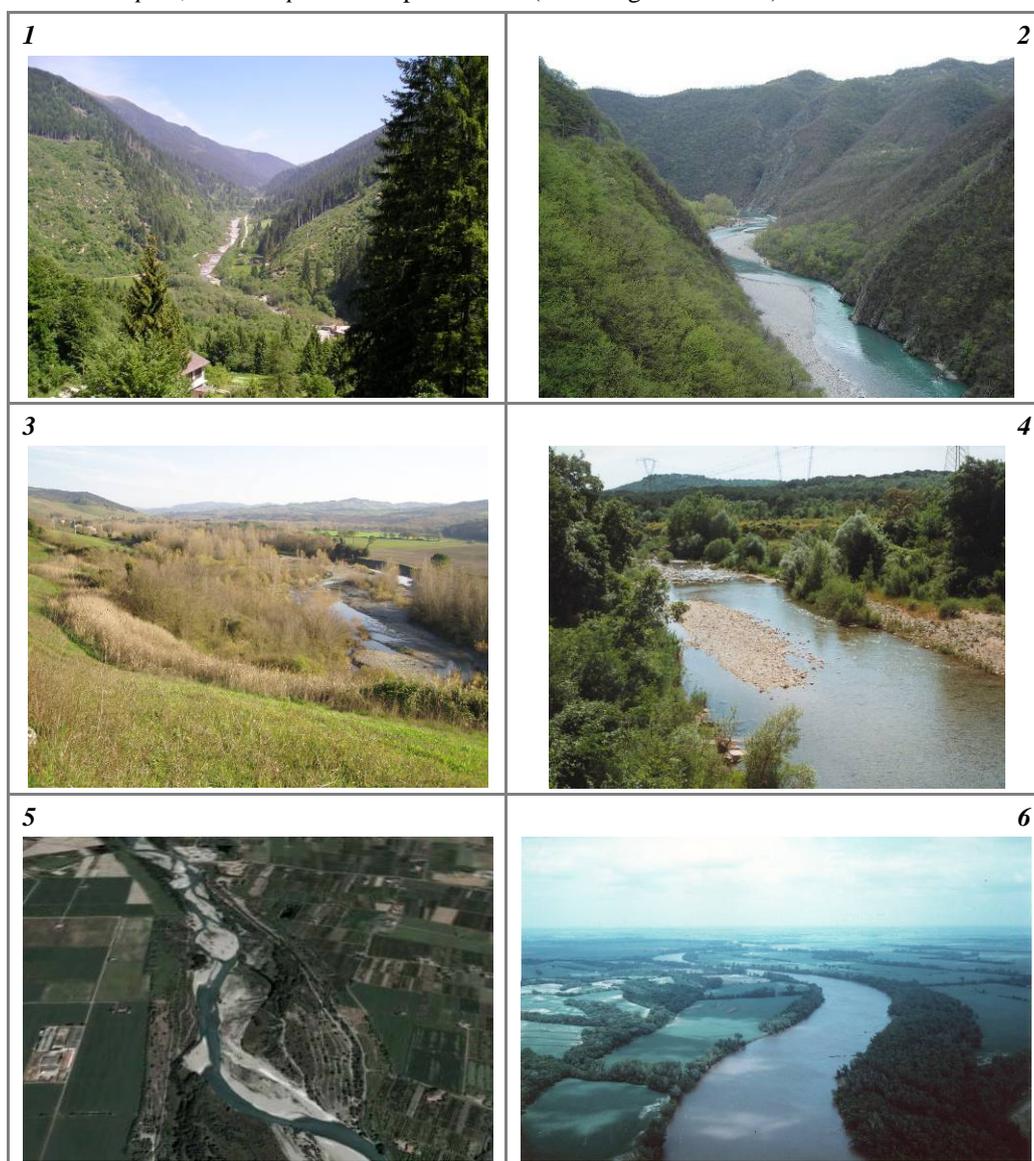
**Figure 4** – Examples of different confinement classes. (1), (2) Confined channels; (3), (4) semiconfined channel; (5), (6) unconfined channels.

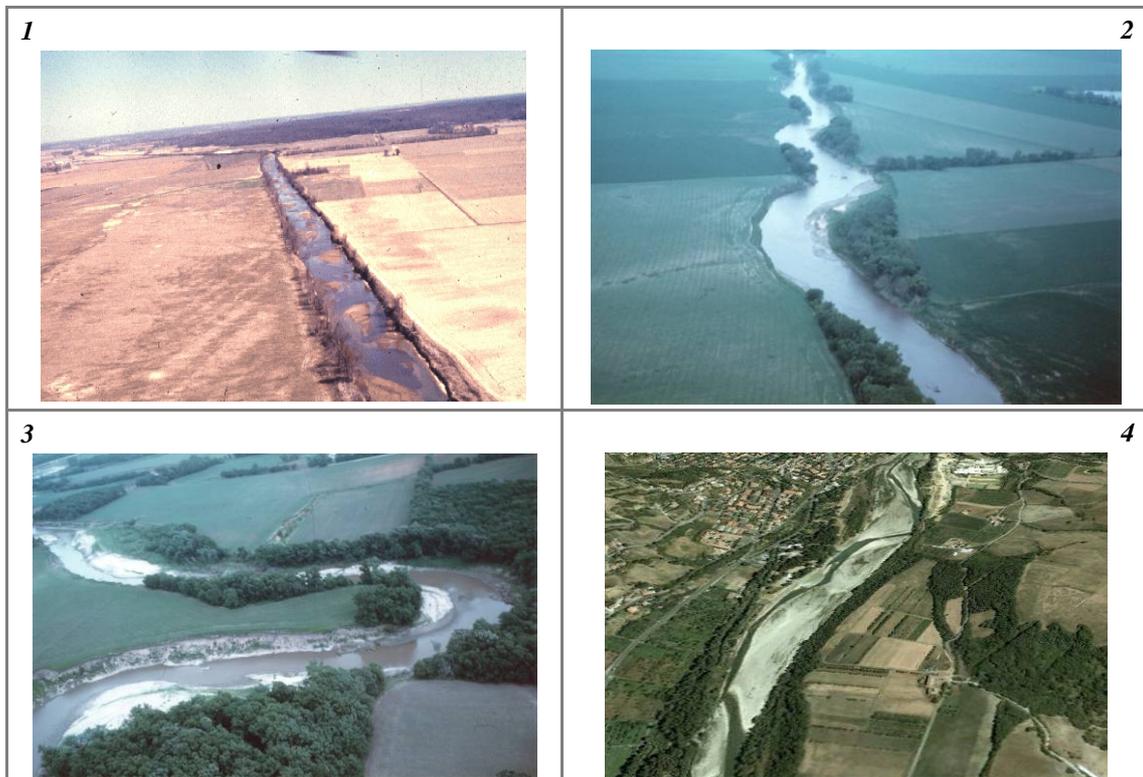
**Figure 6** – Examples of morphologies of semiconfined and unconfined channels. (1) Straight; (2) sinuous; (3) meandering; (4) sinuous with alternate bars.

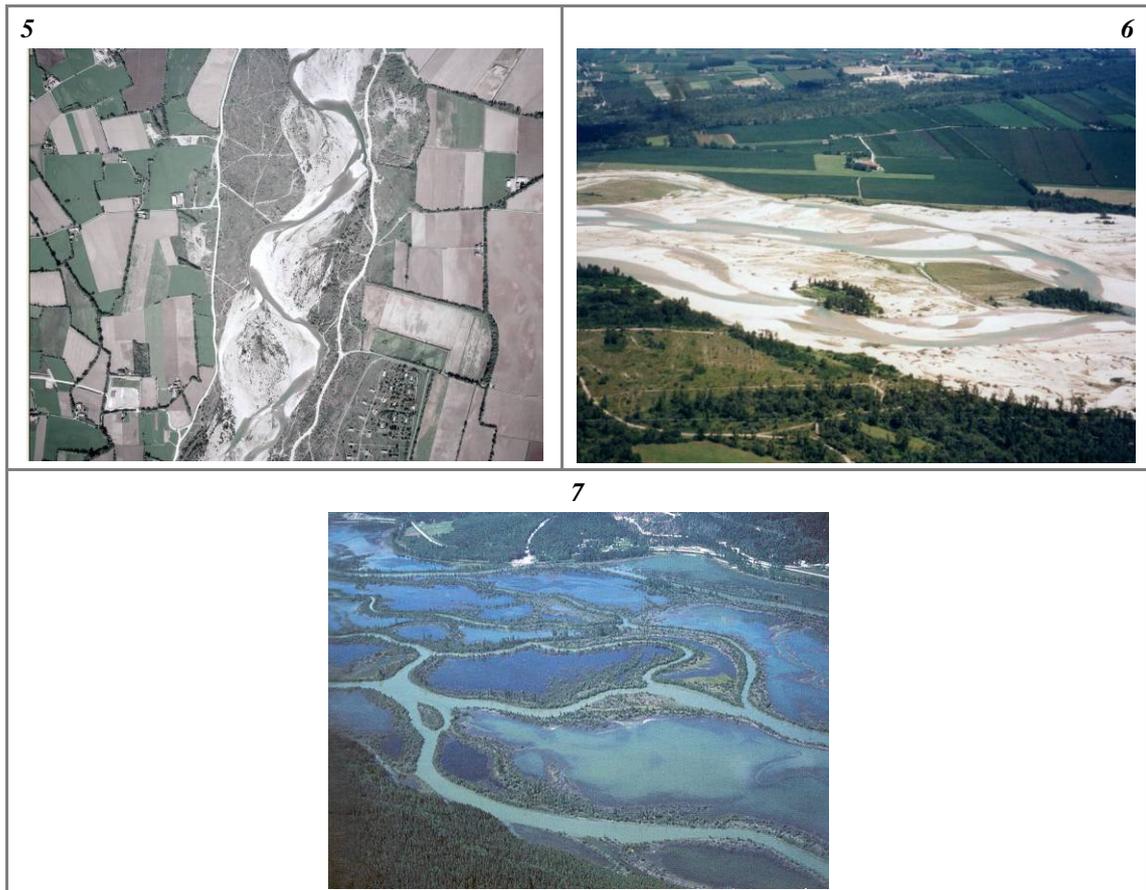
**Figure 6 (continued)** – Examples of morphologies of semiconfined and unconfined channels. (5) Wandering; (6) braided; (7) anastomosing (the islands and floodplain are inundated).

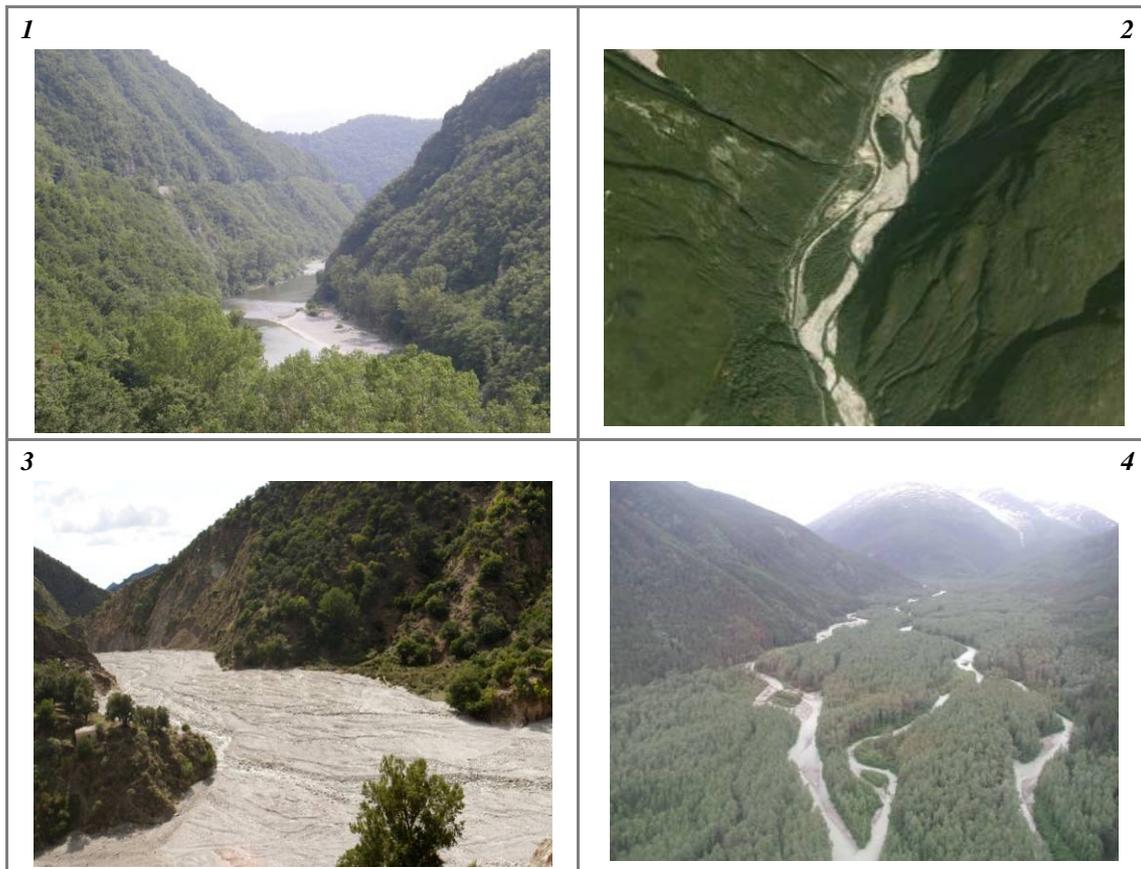
**Figure 7** – Morphologies of confined channels. (1) Confined single-thread; (2) confined wandering; (3) confined braided; (4) confined anastomosed.

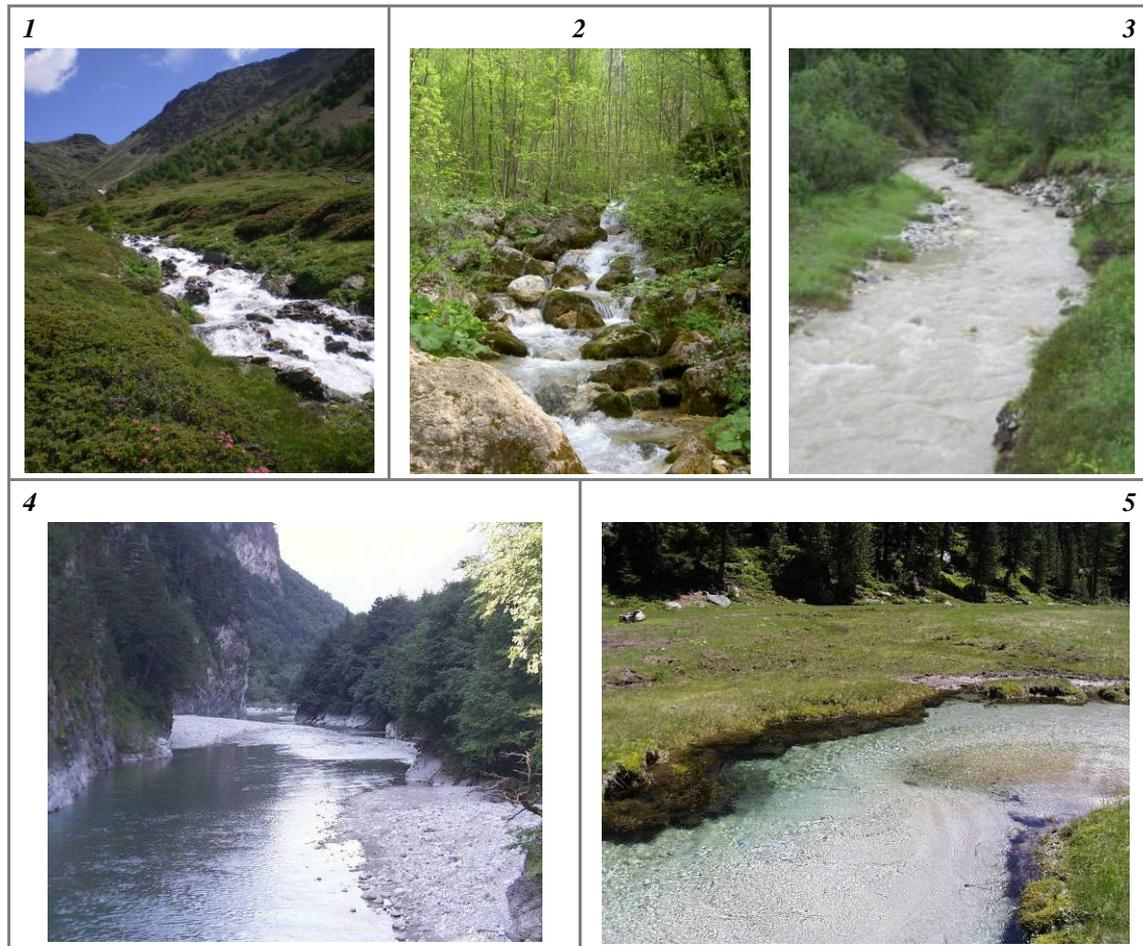
**Figure 12** – Bed configurations at reach scale in mobile bed streams. (1) *Cascade*; (2) *step pool*; (3) *plane bed*; (4) *riffle-pool*; (5) *dune-ripple*.

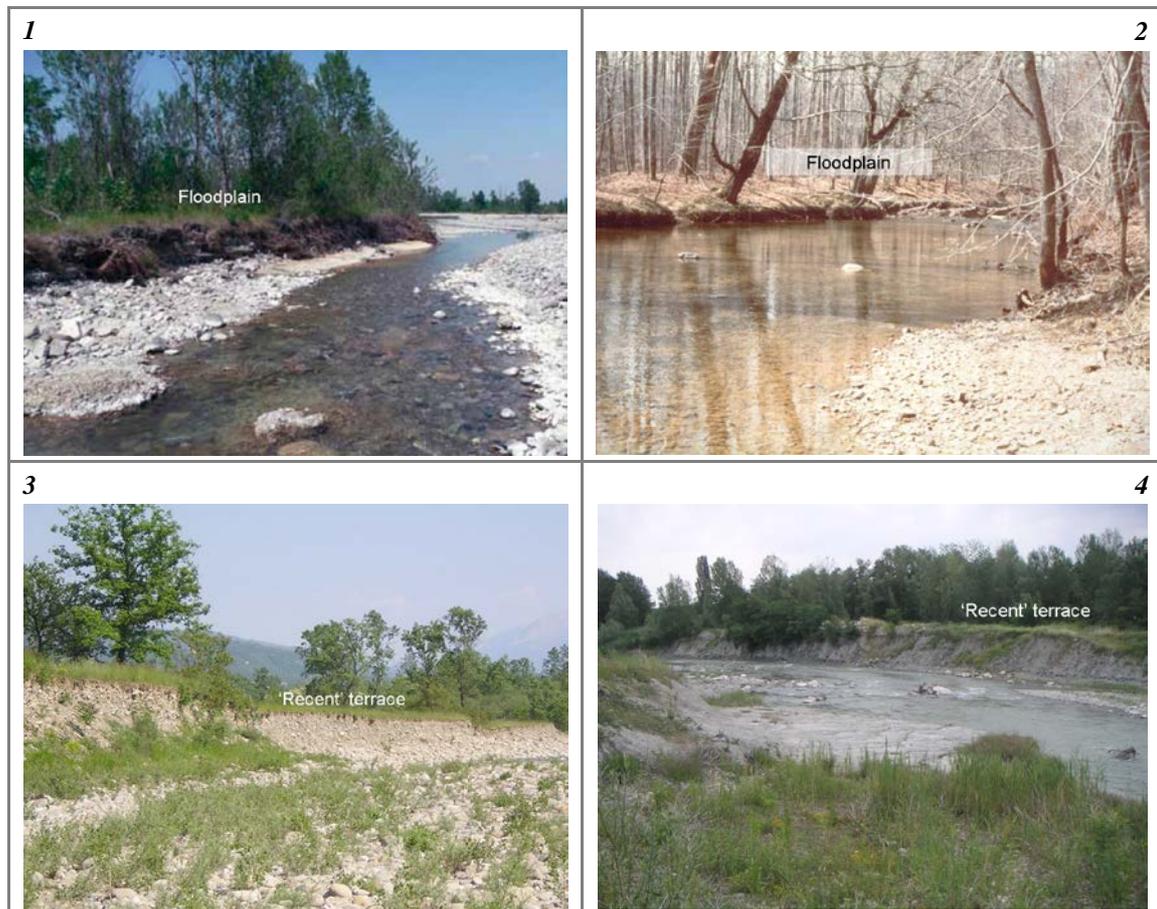
**Figure 23** – Differences between floodplain and “recent” terrace. (1) and (2) Examples of modern floodplain (note the very limited differences in elevation with channel bars); 3: “recent” terrace generated by a bed incision of about 2÷3 m; 4: “recent” terrace generated by an intense incision (> 3 m).

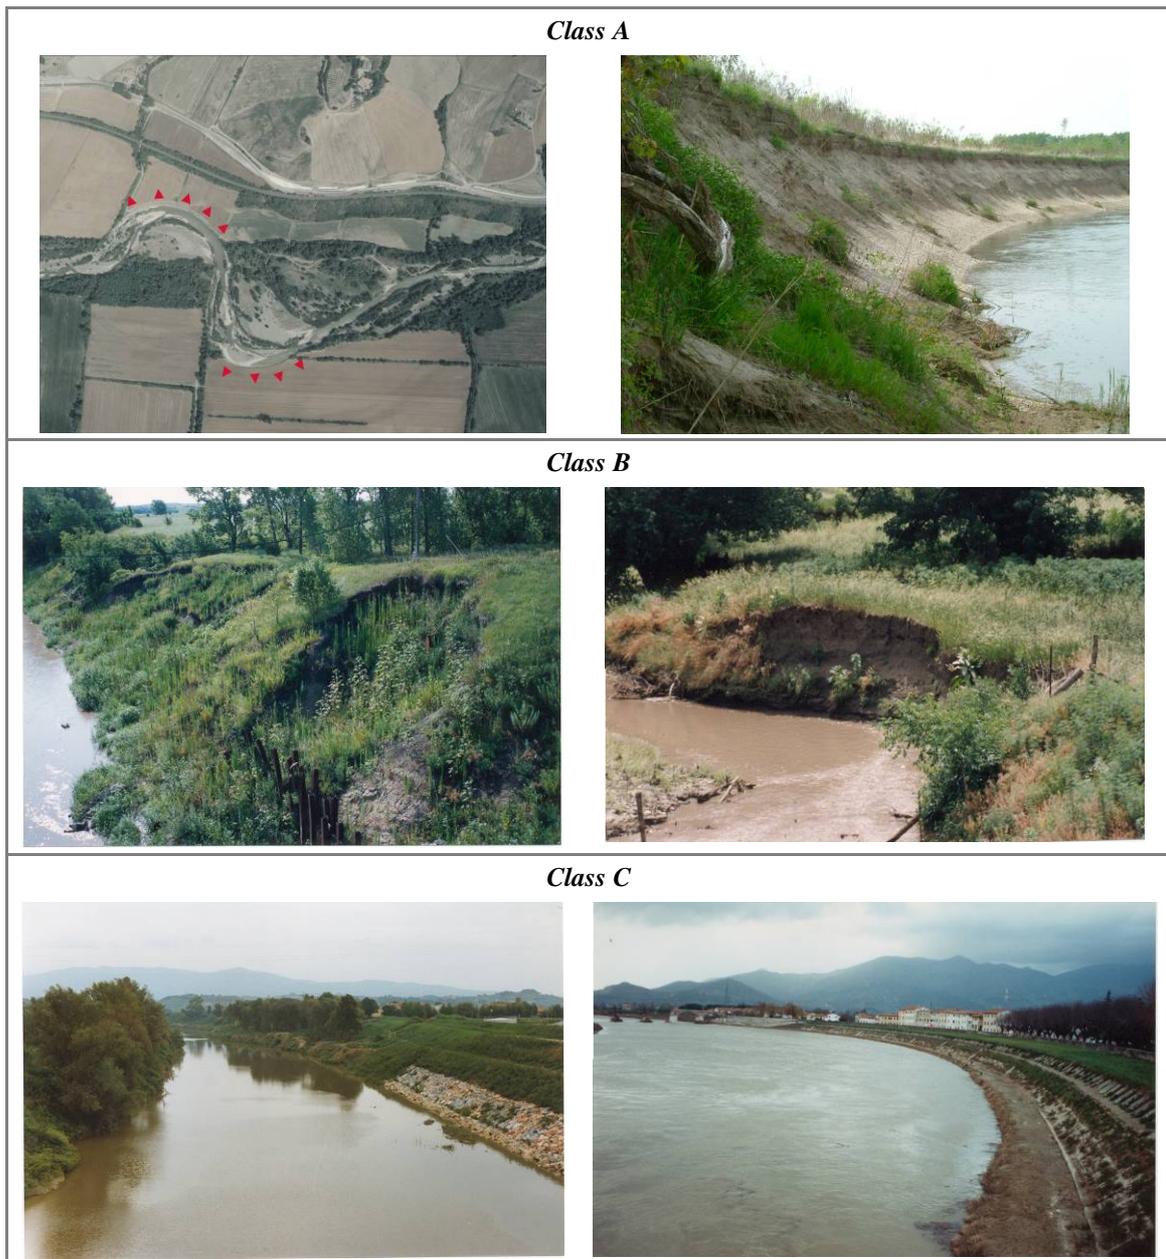
**Figure 32** – Processes of bank retreat. *Class A*: frequent retreating banks, particularly along the outer side of bends (red arrows, photo on the left). *Class B*: this class includes reaches with bank erosion observed only locally. *Class C*: absence of eroding banks due to bank protections and/or absent channel dynamics.

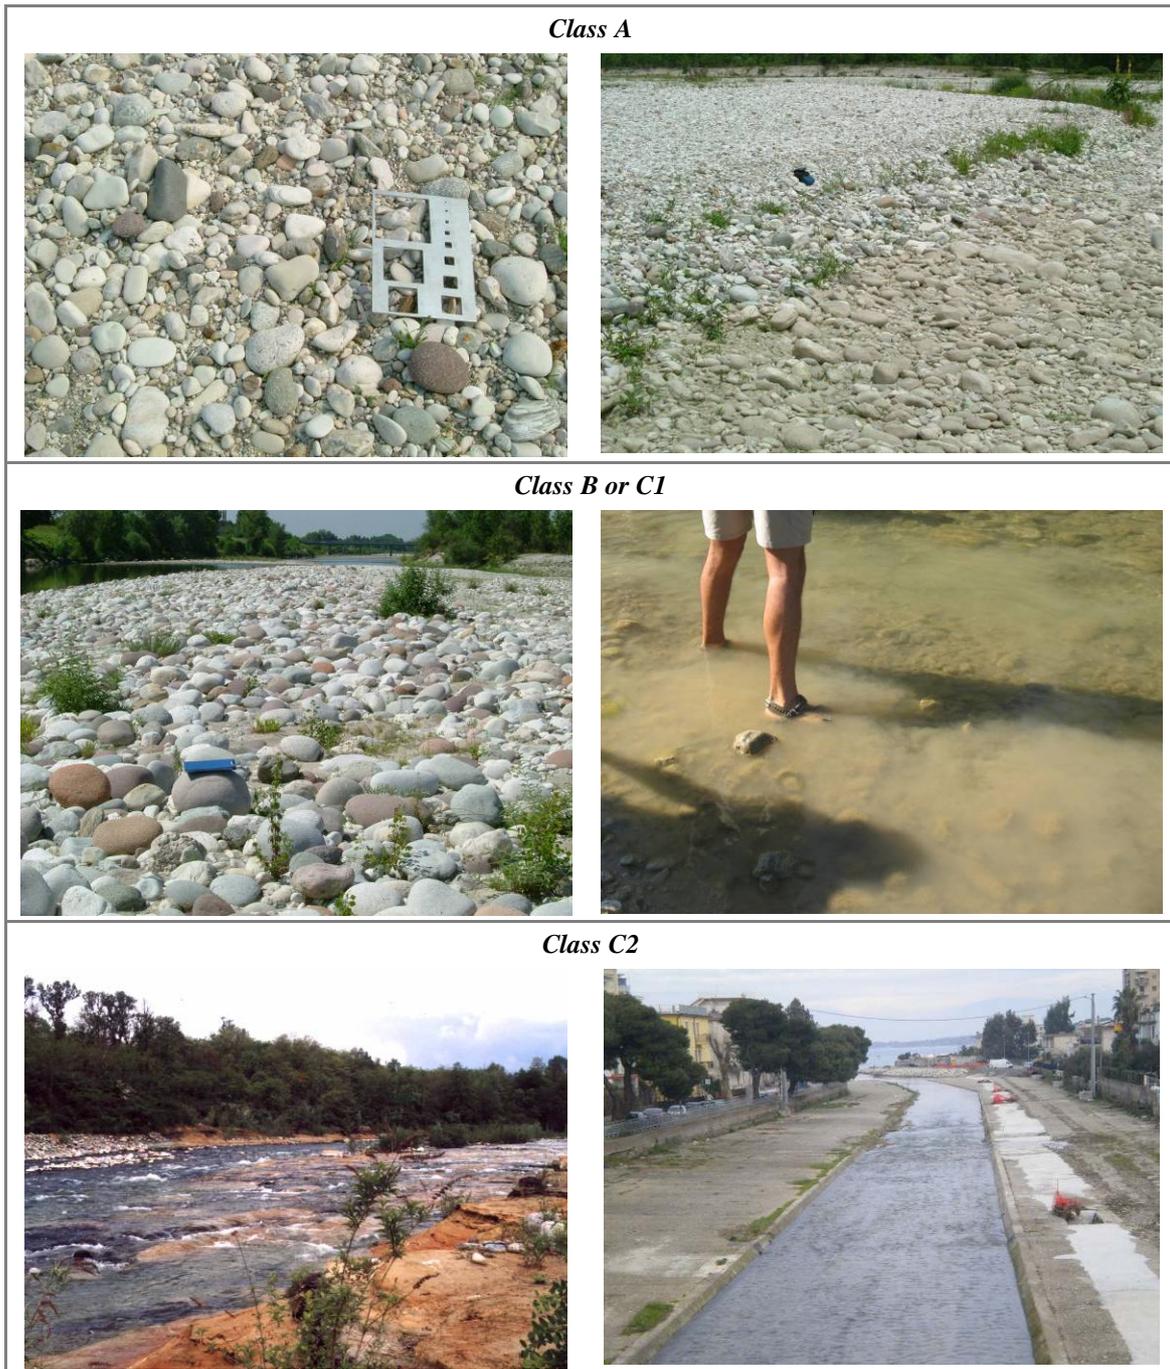
**Figure 44** – Alterations of substrate in semi- and unconfined channels. *Class A*: natural sediment heterogeneity in an unconfined channel. *Class B* or *C1*: presence of armouring (photo on left) or clogging (photo on right) (assignment to *Class B* or *C1* will depend on the extension of armouring and/or clogging along the site). *Class C2*: bedrock outcroppings due to bed incision (photo on left) or completely altered substrate because of bed revetment (photo on right).

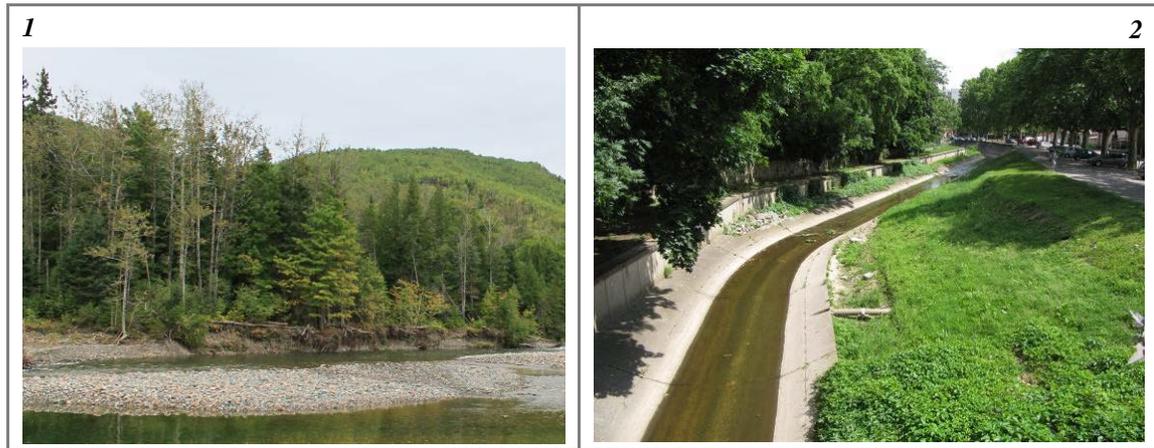
**Figure 46** – Vegetation in the fluvial corridor. (1) Presence of vegetation connected with the channel in a semiconfined reach; (2) absence of vegetation (right) or vegetation disconnected by the stream channel because of the presence of walls.

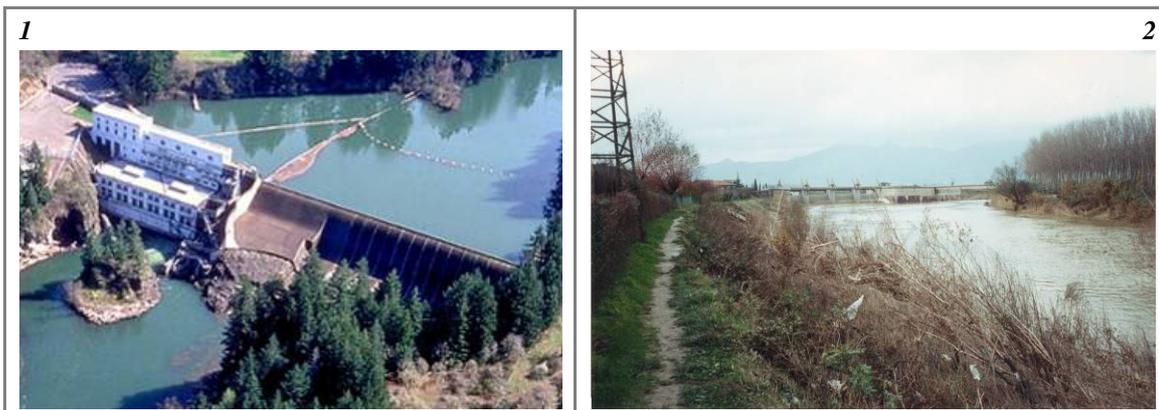
**Figure 52** – Alteration of discharges. Typical alteration structures. (1) Dam; (2) spillway.

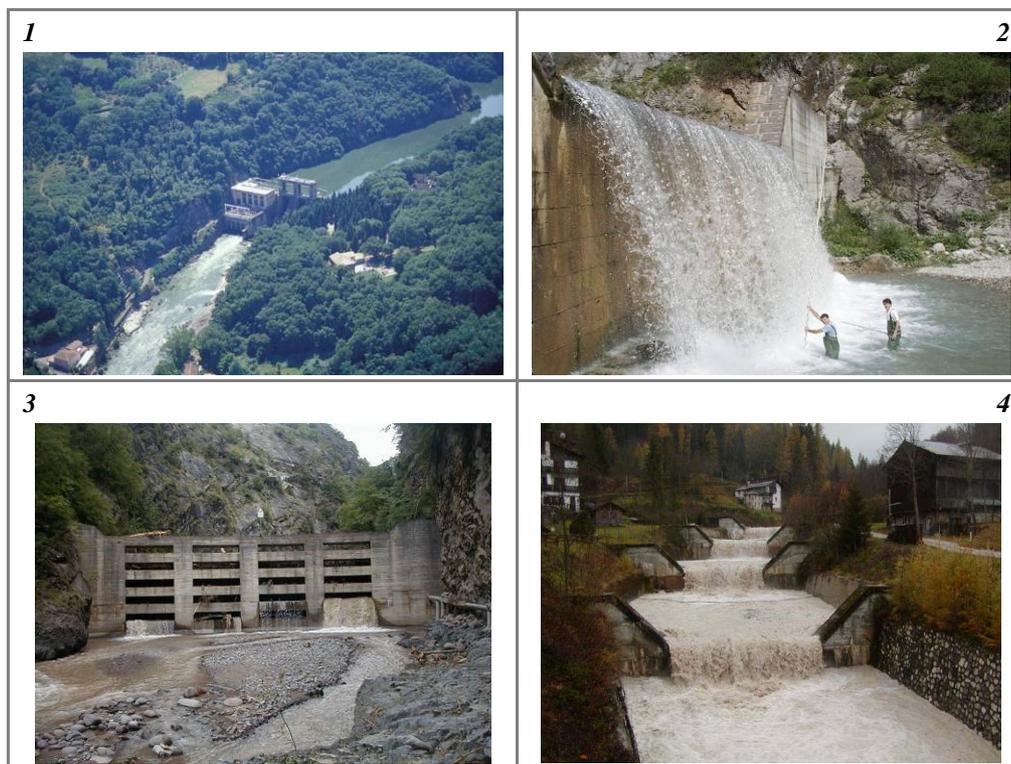
**Figure 55** – Transversal structures of alteration of sediment discharges in mountain areas. (1) Dam; (2) retention check dam; (3) open check dam; (4) sequence of stepped consolidation check dams.

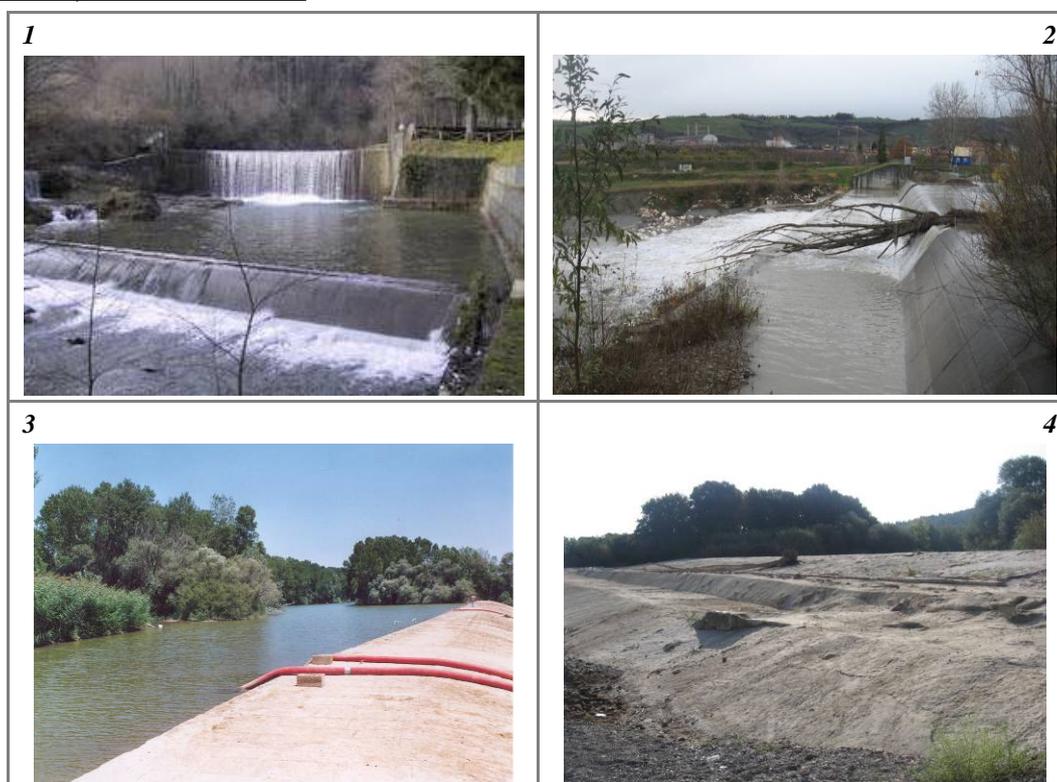
**Figure 56** – Transversal structures of alteration of sediment discharges in hilly and lowland areas. (1) Consolidation check dam; (2) abstraction weir; (3) not filled abstraction weir; (4) filled abstraction weir.

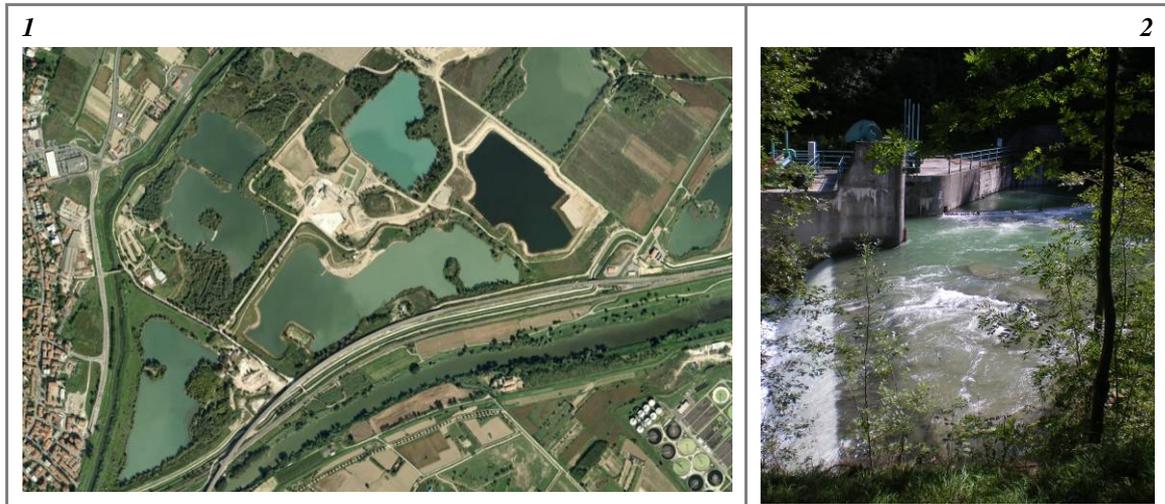
**Figure 58** – Other structures (besides those defined for A1) that can cause an alteration of discharges within a reach. (1) Retention basins; (2) discharge abstraction.

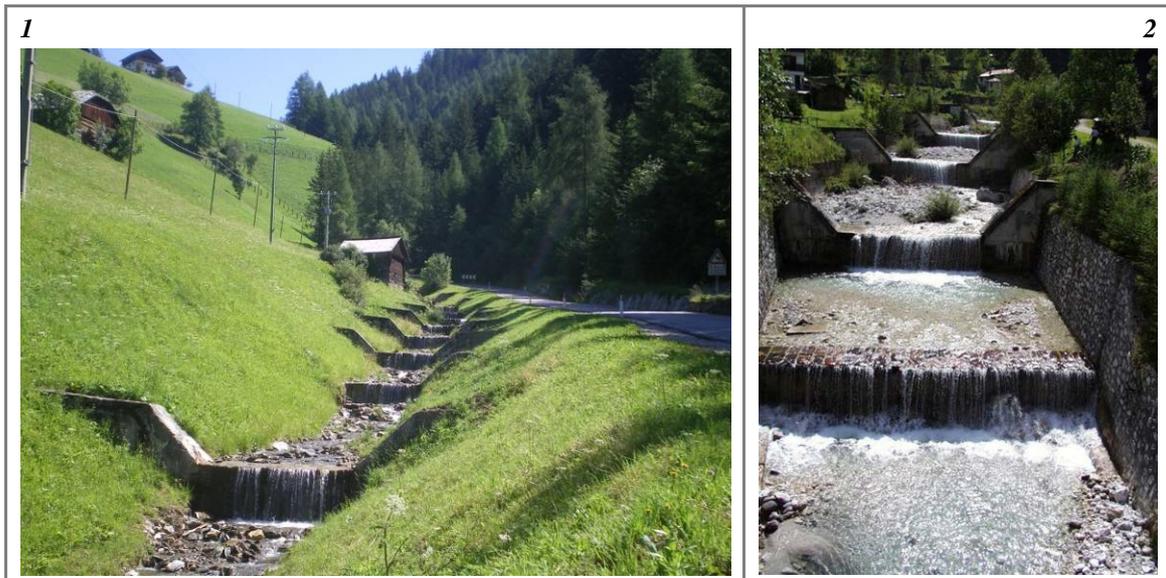
**Figure 62** – Cases with very high density of transversal structures ( $> 1$  every 100 m in mountain areas): an additional score of 12 is applied.

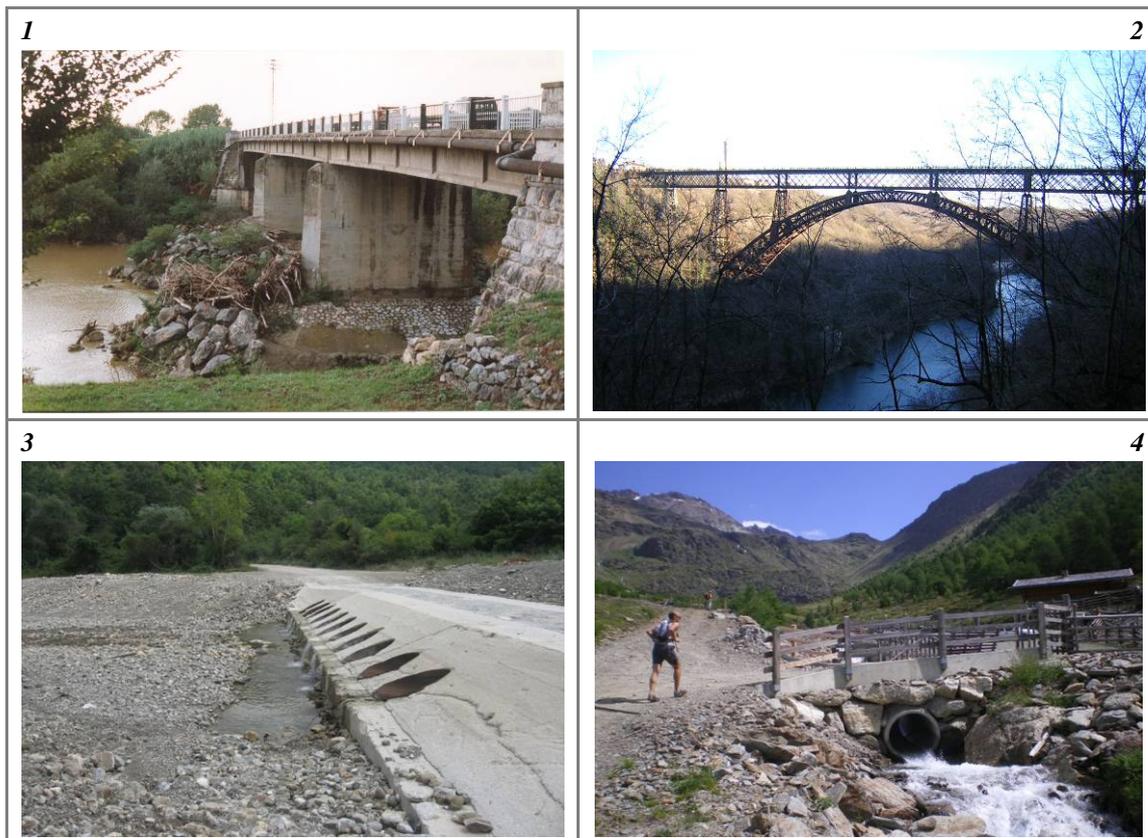
**Figure 63** – Crossing structures. (1) Bridge with interference on fluvial dynamics; (2) crossing structure unrelated to the fluvial corridor; (3) ford with culverts; (4) culvert.

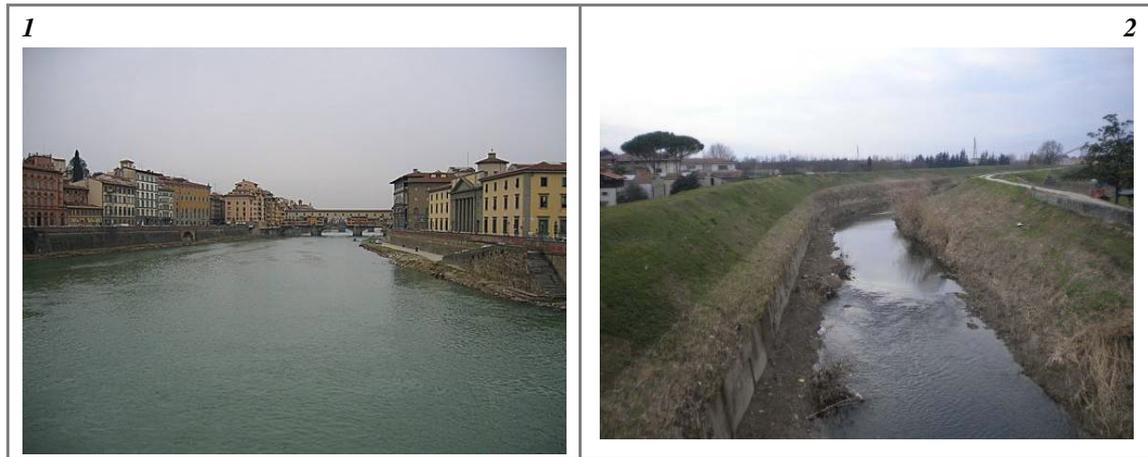
**Figure 70** – Cases of bank protections plus levees in contact occurring for most of the reach (> 80%), for which a score of 12 is added.
